**INVESTIGATION**

**Bryson Crash**

**INVESTIGATION OF THE BRYSON CRASH****EXPERT'S SUPPLEMENTAL REPORT****JUNE 14, 2024****A. INTRODUCTION**

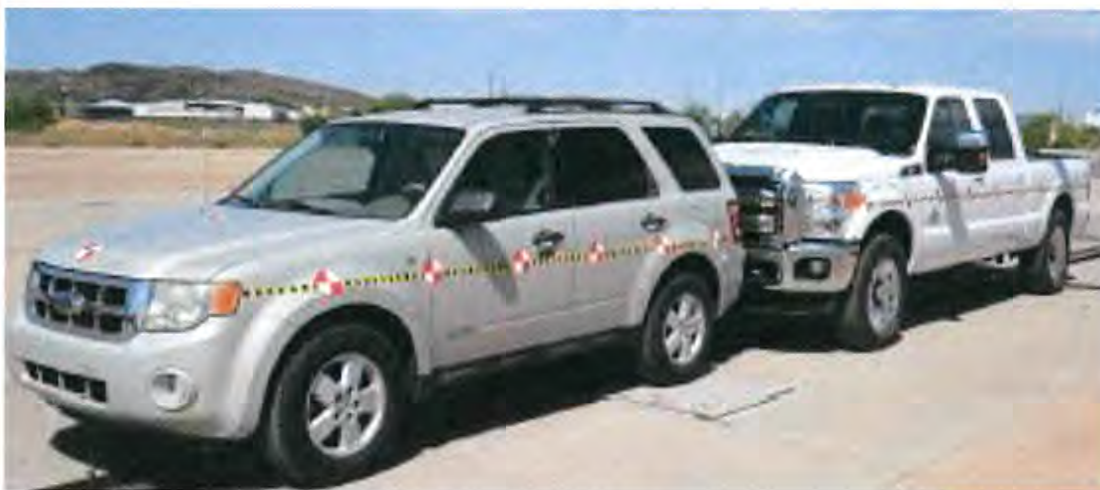
**Image 1: Pre-Test Vehicle Condition**

Both vehicles were ballasted, instrumented and the impact velocity of the F-250 was reported as 49.9mph with the test set up so that the front of the F-250 struck the rear of the Escape. The Escape was positioned to the right of the F-250 (and the test guide rail centerline) with an offset of about 10.8". To date, there has been no opportunity to inspect the tested vehicles. Image 1 shows the pre-test impact configuration.

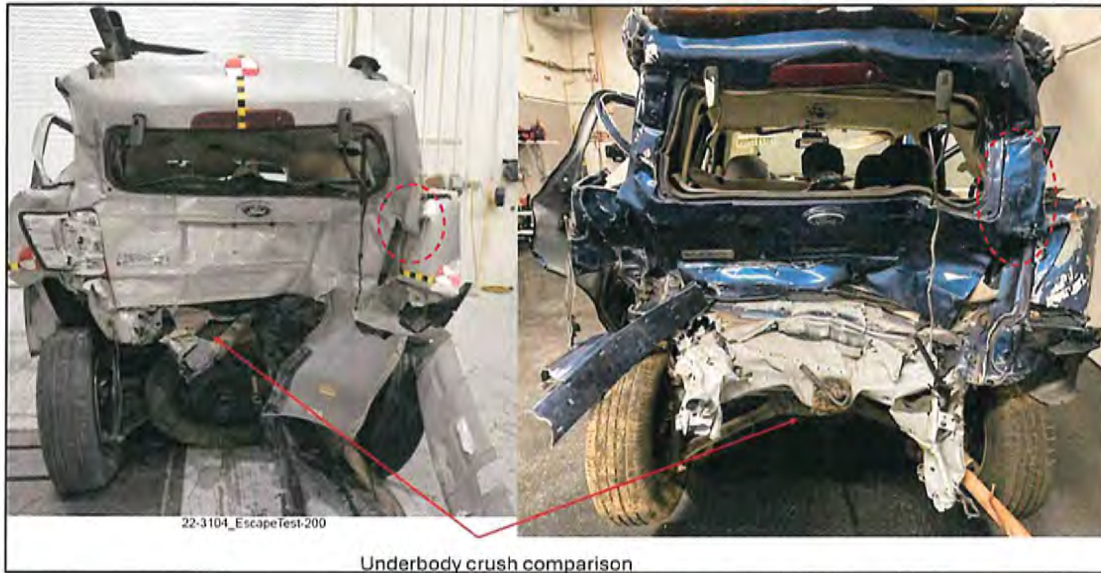
**Image 2: Deformed Escape Comparison – Rear View**

12. The tested Escape exhibited significantly increased underbody deformation than the subject Escape – Image 2 shows a comparison of the two vehicles, with the tested Escape on the left and the subject vehicle on the right. The tested Escape's underbody has been deformed, the rear rails are not exposed, and the rear floor is not visible. There was vertical alignment of the vehicle energy absorbing structures in the test.

13. The lateral vehicle overlap in the test does not match the subject condition. Image 2 shows that the right side of the subject liftgate pillar exhibits direct contact deformation (circled), whereas the tested Escape exhibits induced damage, or non-direct deformation. This indicates that the alignment of the vehicles was further offset in the test than the subject crash, resulting in less lateral overlap and therefore less structural engagement in the crash test.

Additionally, the crash test overlap and setup are unrepresentative of the subject crash. The overlap between the two vehicles was additionally offset by at least 4" based on the deformation pattern of the liftgate and the width of this structure, resulting in less lateral engagement in the crash test than the subject test. Less lateral engagement results in the impact being concentrated on a smaller area of the Escape. It is possible that the guidance system used for the F-250 was unable to maintain the test setup

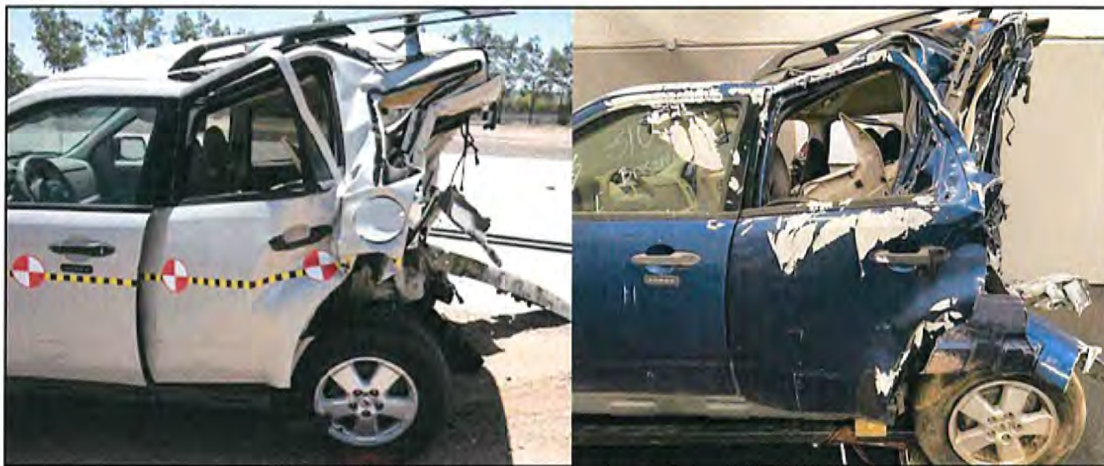
**Image 3: Deformed Escape Comparison – Left Side View**

14. The tested Escape exhibited less deformation on the left bodyside rearward of the rear door than the subject Escape – Image 3 shows a comparison of the two vehicles, with the tested Escape on the left and the subject vehicle on the right. The tested Escape's C pillar is still visible, and the fuel filler door undeformed whereas the subject Escape's C pillar has been deformed forward of the rear door's trailing edge. The crash tested Escape's roof is also less crushed.

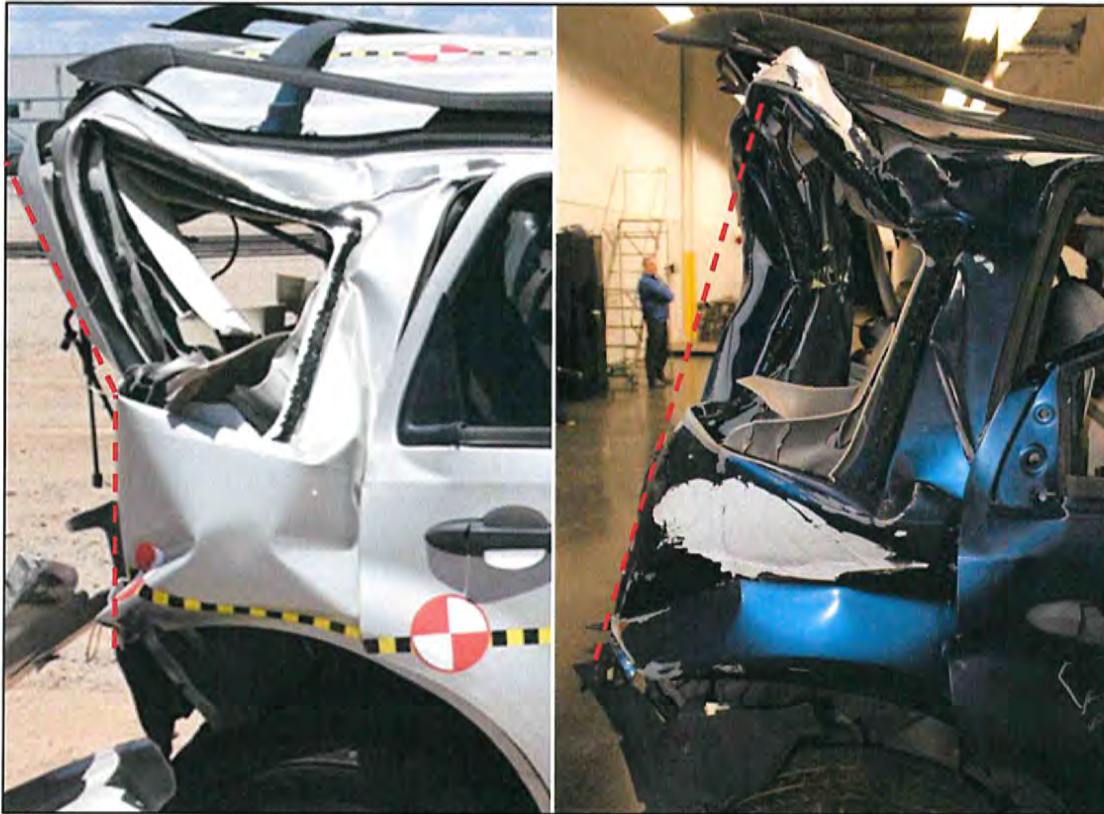
Image 4: Deformed Escape Comparison – Right Side View

15. The tested Escape exhibited less deformation on the right bodyside rearward of the rear door than the subject Escape. Image 4 shows a comparison of the two vehicles, with the tested Escape on the left and the subject vehicle on the right. The crash tested Escape's roof is less deformed, and the rear quarter glass aperture shows less collapse, resulting in the D pillar having an angular

component rearward rather than being pushed forward, as in the subject Escape, as highlighted by the dashed lines.

However, the Exponent test does not test Grimes' cargo hypothesis and so by omitting cargo in the testing, he has not followed a scientific methodology to attribute seat deformation to the cargo. Additionally, as noted earlier, there was significantly less upper trunk compartment crush (and roof crush) in the crash test due to the lower engagement height of the F-250. This results in more vertical luggage space being maintained and would allow luggage to move upward rather than forward in the vehicle. The higher ride height of the F-250 in the subject crash resulted in more of the trunk space being crushed (Image 4).

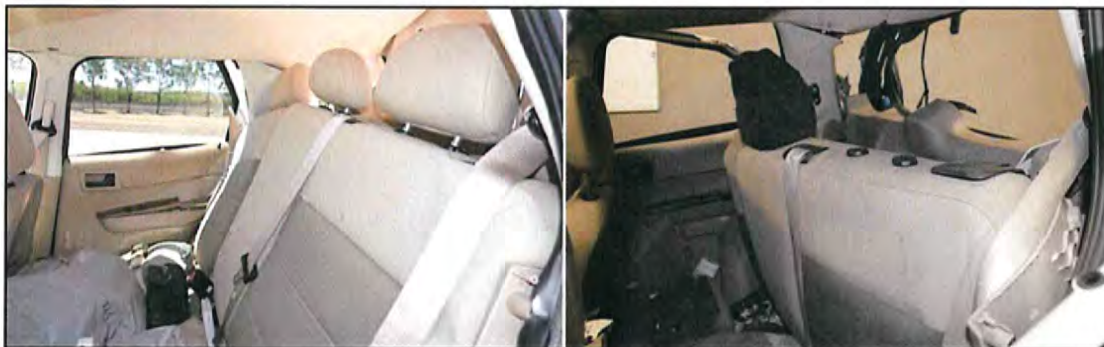
Image 5: Rear Seat Comparison

16. The tested Escape exhibited less rear seat static deformation (forward in vehicle) than the subject Escape – Image 5 shows a comparison of the two vehicles, with the tested Escape on the left and the subject vehicle on the right. The seat back angle is still rearward in the tested Escape, with the headrests adjacent to the C pillar. Whereas the subject Escape's seat back angle is forward, with the headrests significantly forward of the C pillar.

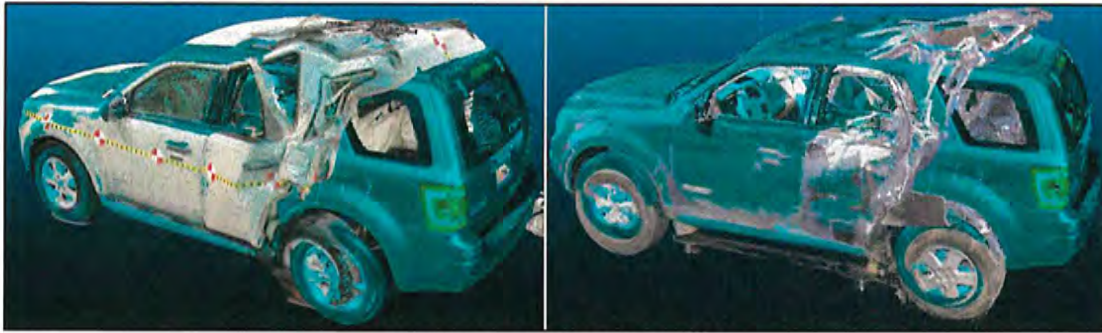
Image 6: Point Cloud Overlays

17. An analysis of overlaid laser scan point cloud data for an exemplar Escape with both the crash test Escape and the subject Escape (Image 6 – crash test on left, subject on right) identifies the following:
- a. The subject Escape's wheelbase (left side) was almost unchanged at 103".
  - b. The crash test Escape's wheelbase (left side) was reduced by about 5".
  - c. The subject Escape's static seat back angle changed from about 65° to the horizontal to greater than 90°, being rotated forward. See Image 7 with the subject Escape on the right.
  - d. The crash test Escape's static seat back angle (post-test) was largely unchanged from the pre-test condition. See Image 7 with the crash test Escape on the left.

Grimes did not conduct a detailed analysis of the structural intrusions or the rear seat static movement between the crash test and subject crash. His only intrusion analysis consisted of an overlay of the point cloud data of the two sets of vehicles, and he opined that the crash test intrusion was higher than the subject crash intrusion. He did not study the intrusion related to the second-row survival space. If the crash test intrusions were higher than the subject crash, this would be unusual and contrary to known compatibility testing data and published reports. In Ford's compatibility research (Roche 1<sup>st</sup> supplemental report) the intrusions were increased with the truck's ride height being increased. In NHTSA's compatibility testing<sup>1</sup> there was a reduction of intrusion by about 5" when a 2006 Ford F-250s with a Blocker beam (SEAS) was crashed into 2002 Ford Focus compared to a F-250 without a Blocker beam. The addition of the SEAS resulted in more structural compatibility and reduced the intrusion in the struck vehicle. The Exponent crash test intrusion increase is likely due to the test setup, including the vehicle ballasting, vehicle overlap and possible park brake engagement of the Escape.

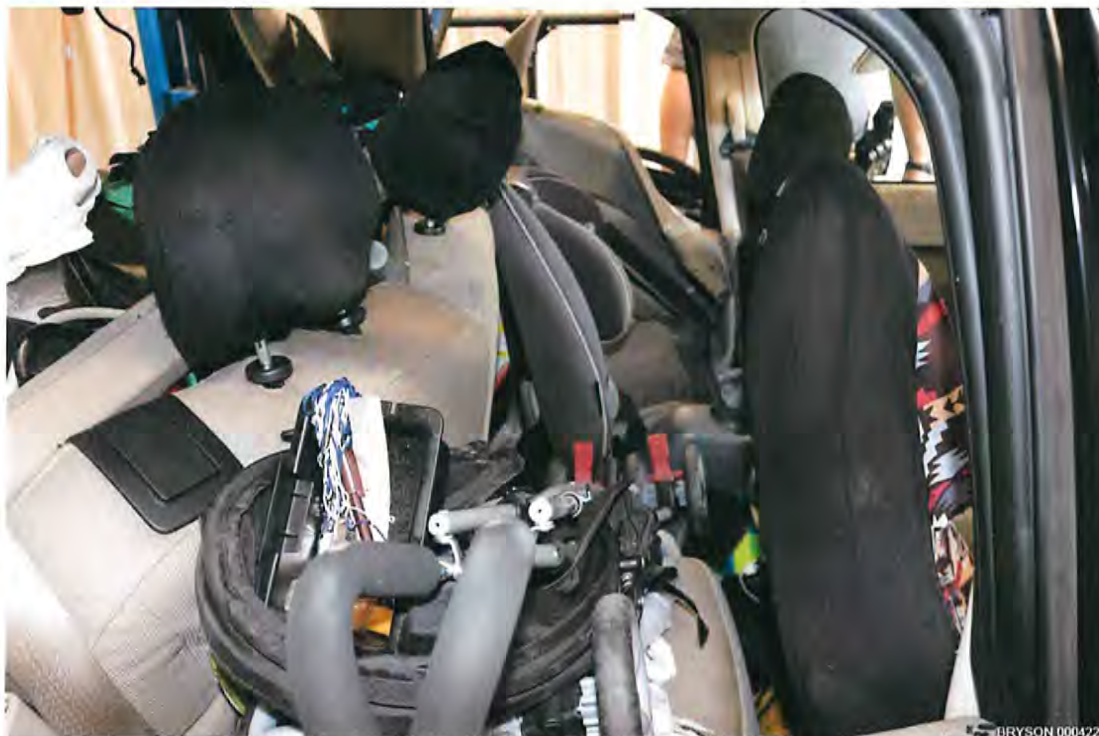
Image 8: Subject Escape Image from GDPS SCRT Report

The Ford Escape test ballast weight used in the crash test does not correspond to either the subject crash condition or normal industry practice for crash testing such as NCAP. The test Escape ballast does not represent the loaded weight of the subject Escape. Both front seats were ballasted with 54lb and 50lb which does not accurately represent the weight of the two occupants (Santana Kelley and Joshua Bryson) at the time of the crash or typical crash dummies at about 167lb each. Locating about 83% (500lb) of the ballast weight in the second-row area is unrepresentative of the weight of the subject Escape during the crash which contained Cohen Bryson (weight 28lb), a car seat (weight about 19lb), a pot plant, a stroller (weight about 11lb) and other small miscellaneous items based on the GDPS SCRT Inspection image – see Image 8. The test was run with the Escape's fuel tank in an empty condition. Typical NHTSA crash test procedures and industry practice is to use an inflammable replacement fluid, such as Stoddard solvent, instead. This ensures the original fuel weight is accurately represented. **The ballasting of the crash test Ford Escape was unrepresentative of the subject crash and did not follow normal industry procedures.**

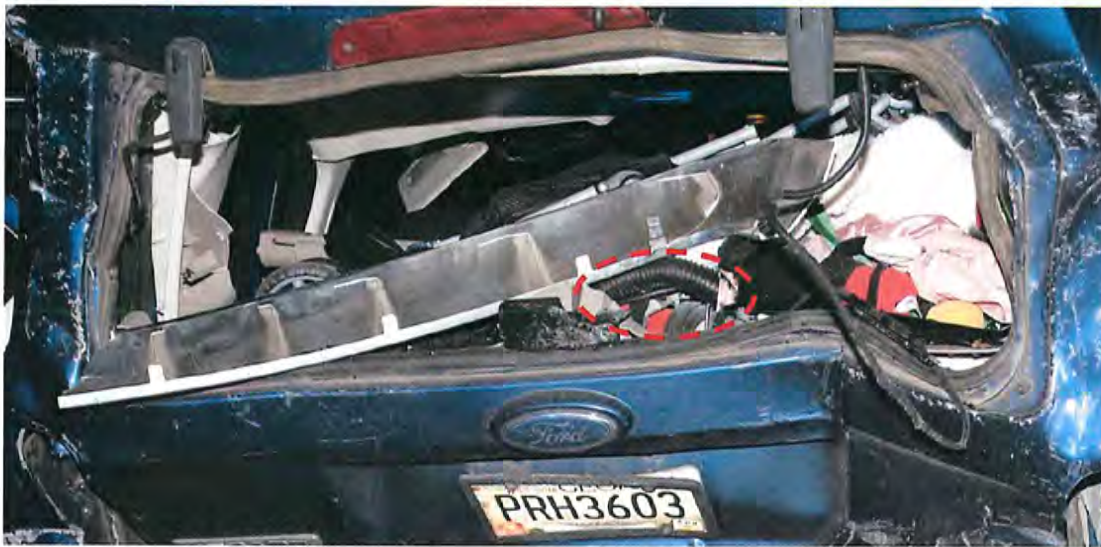
Image 11: Crash Scene Image of the subject Escape

The cargo in the subject Escape consisted of a shop-vac, an umbrella stroller, two camping chairs and a bag of clothing (per Plaintiff's responses to RC's second interrogatories). From the images available from

the scene and subsequent inspection (Images 11 and 12) the shop-vac location is on the right side of the luggage compartment. Additionally, the shop-vac canister was significantly crushed during the crash – Image 13. Despite this information, no attempt was made to add the cargo to the crash test to determine the influence, if any, of the cargo on the vehicle intrusions. Grimes' claims that:
